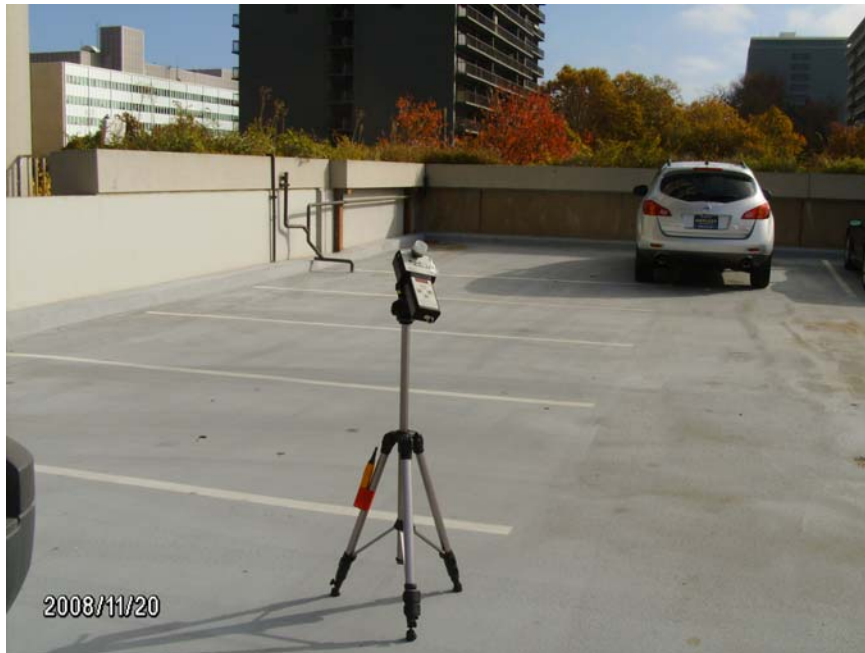
- 1) Image of ambient air sampling location on garage rooftop area of BOE building (Subject Building) located at 450 N Street, Sacramento.

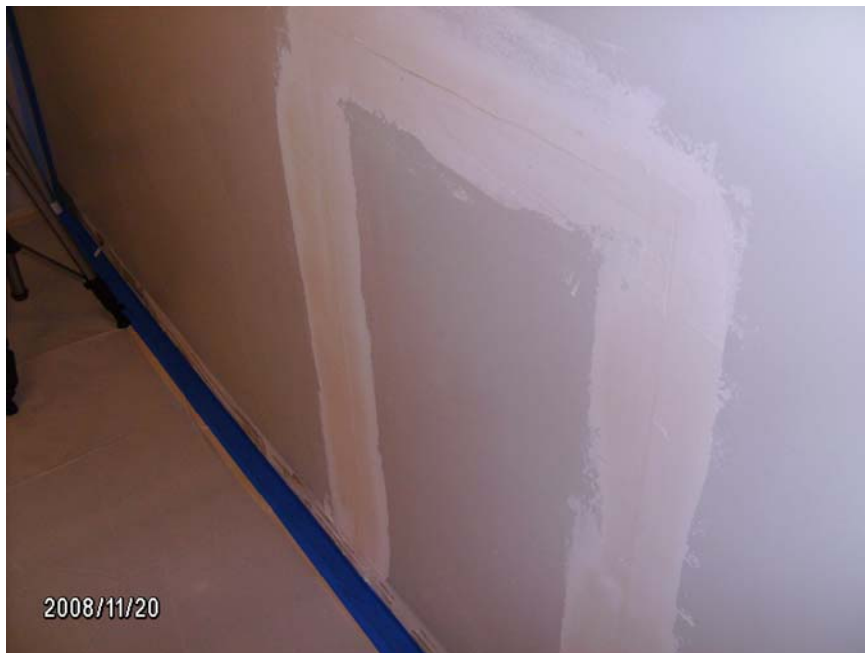
- 2) Image of wallboard repair within interior of LCD-C-1 containment area at time of assessment. Note sheetrock repair at area formerly removed for inspection.

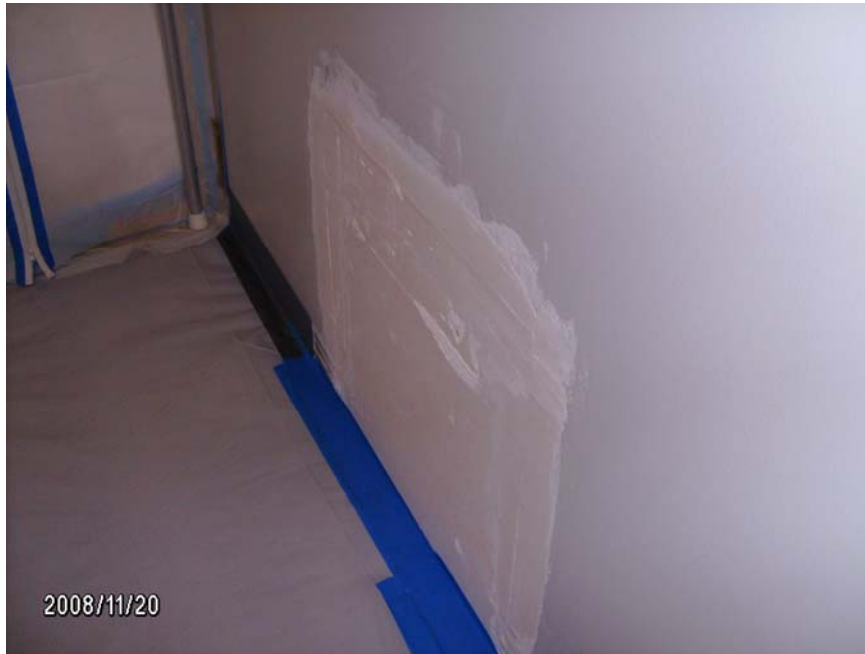
3) Image of reconstructed wall within interior of containment LCD-C-2 at time of assessment.

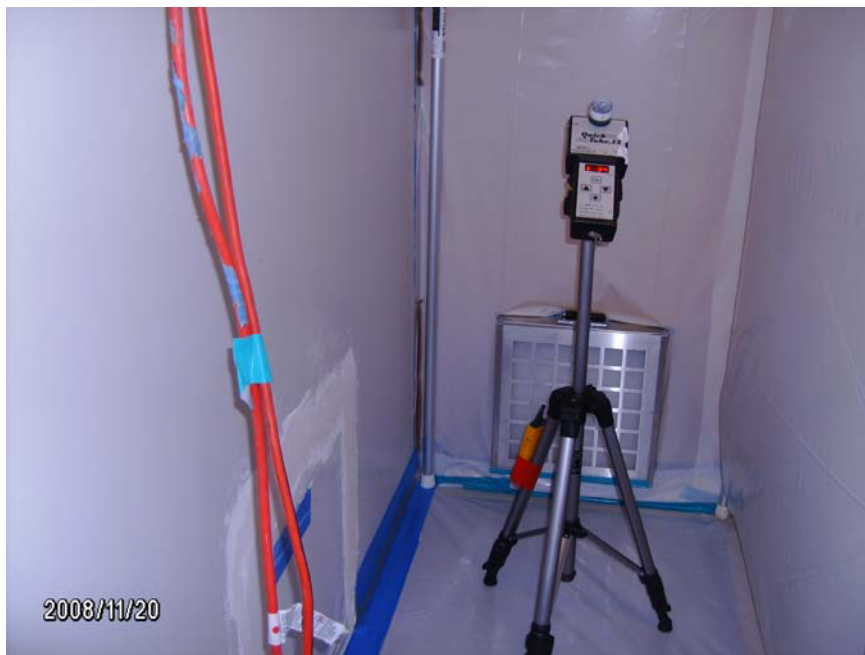
4) Image of interior entry chamber construction and air sampling activity performed within LCD-C-2 at time of assessment.

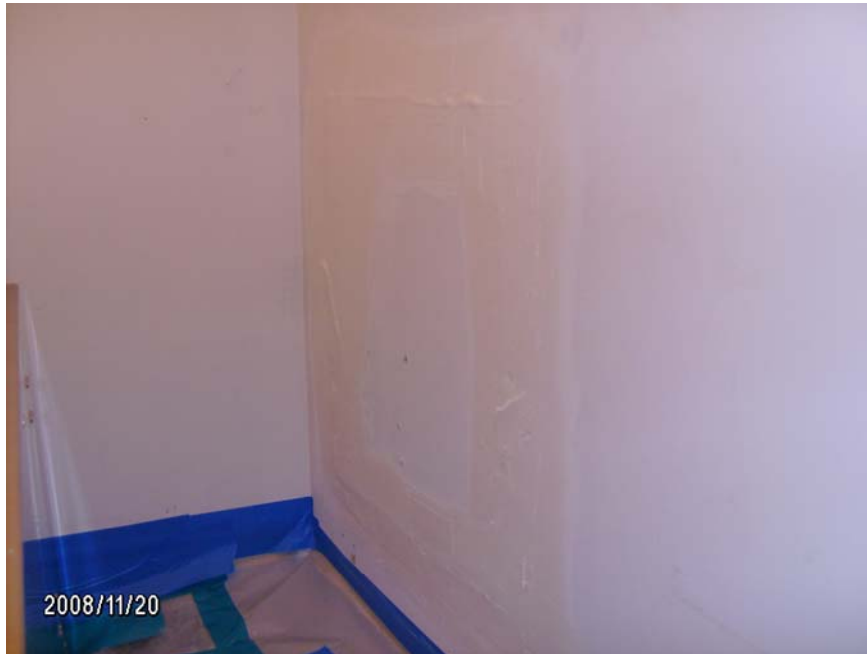
5) Image of baseboard removal and wall repair within LCD-C-5 at time of assessment.

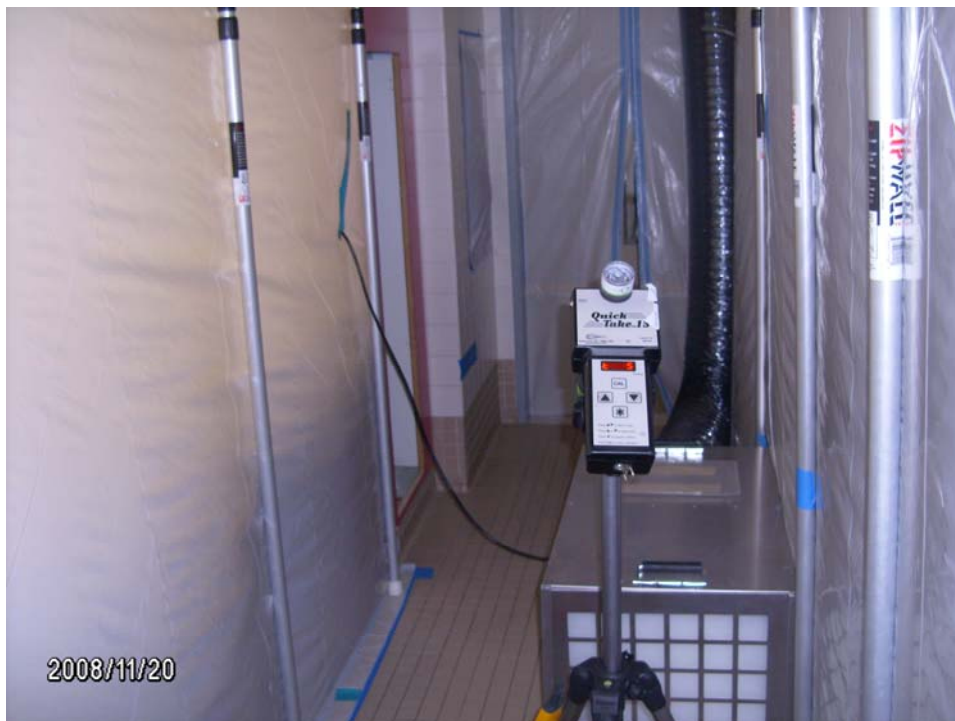
6) Image of air sampling activity performed within Women's Restroom LCD-C-6 at time of assessment.

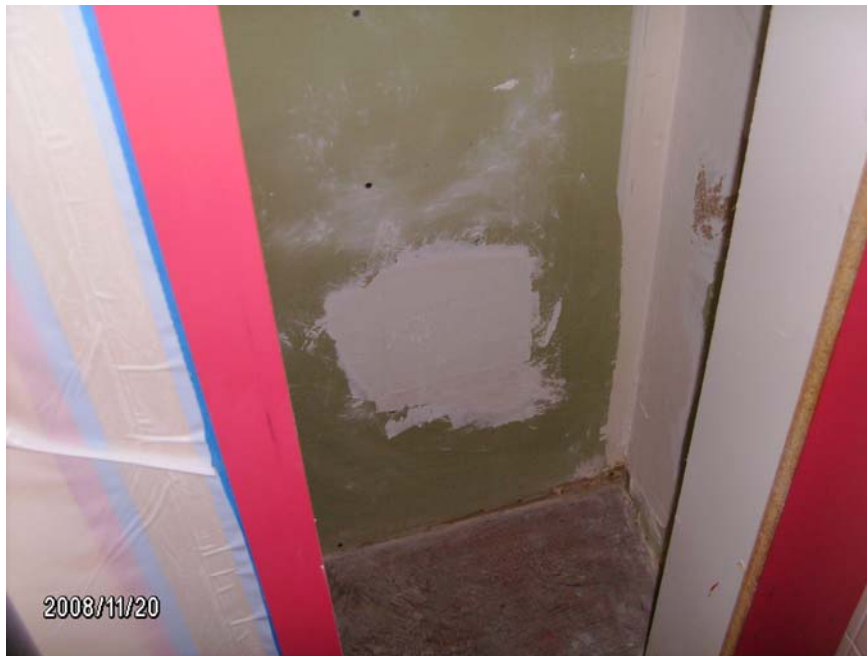
- 7) Image of exposed wall cavity as viewed from interior side of containment LCD-C-6 at time of assessment.

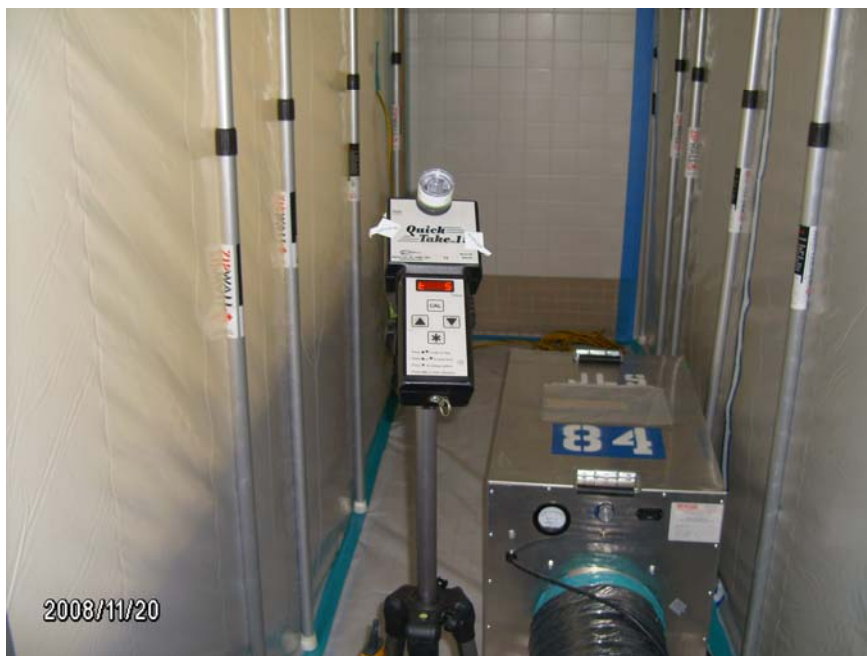
- 8) Image of air sampling and containment systems present within LCD-C-9 containment area at time of assessment.

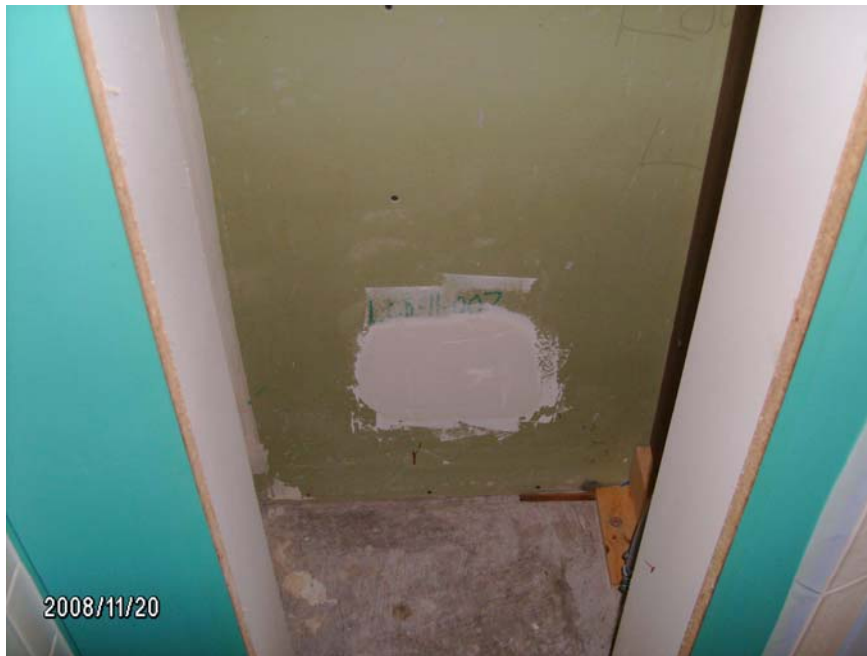
- 9) Image of wallboard removal from cavity within LCD-C-9 containment system at time of assessment.

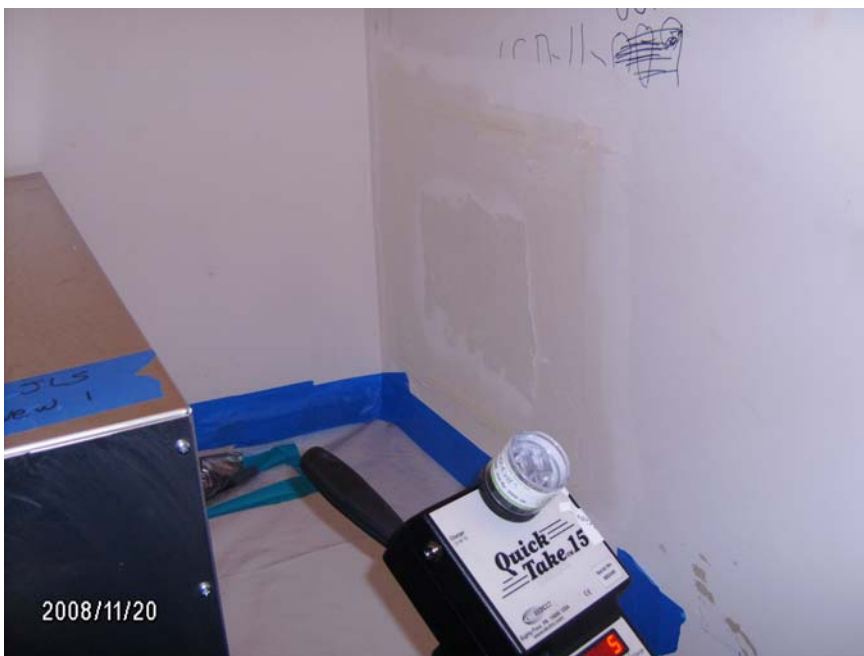
- 10) Image of air sampling and wallboard repair following LCD's inspection within LCD-C-10 at time of clearance assessment.

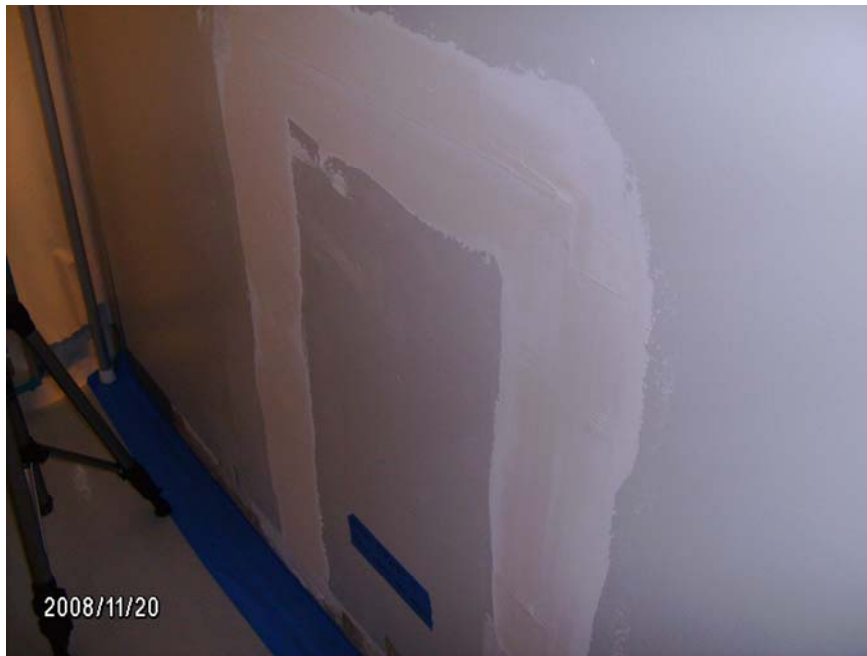
11) Image of wallboard repair performed within LCD-C-8 containment at time of assessment.

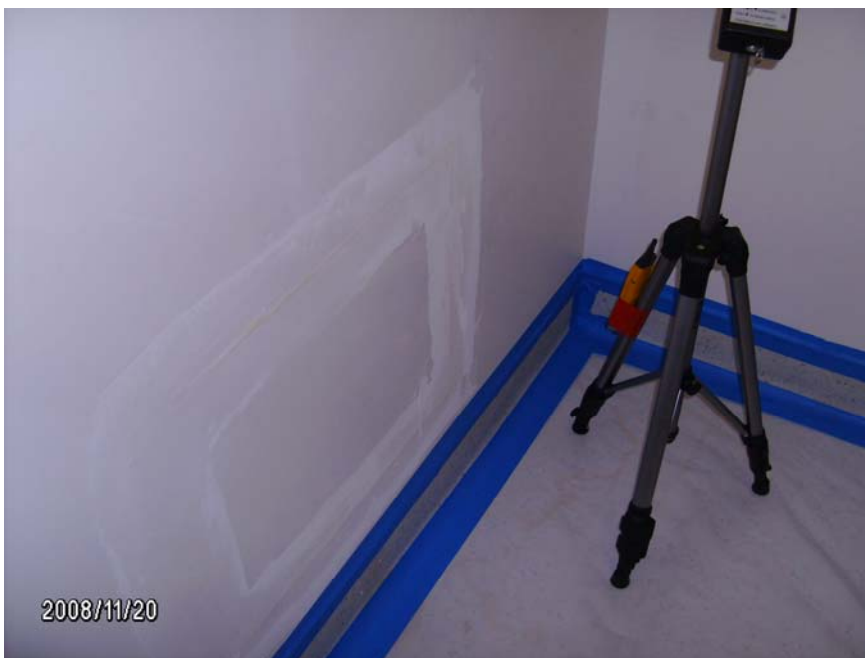
12) Image of wallboard repair within LCD-C-3 containment at time of assessment.

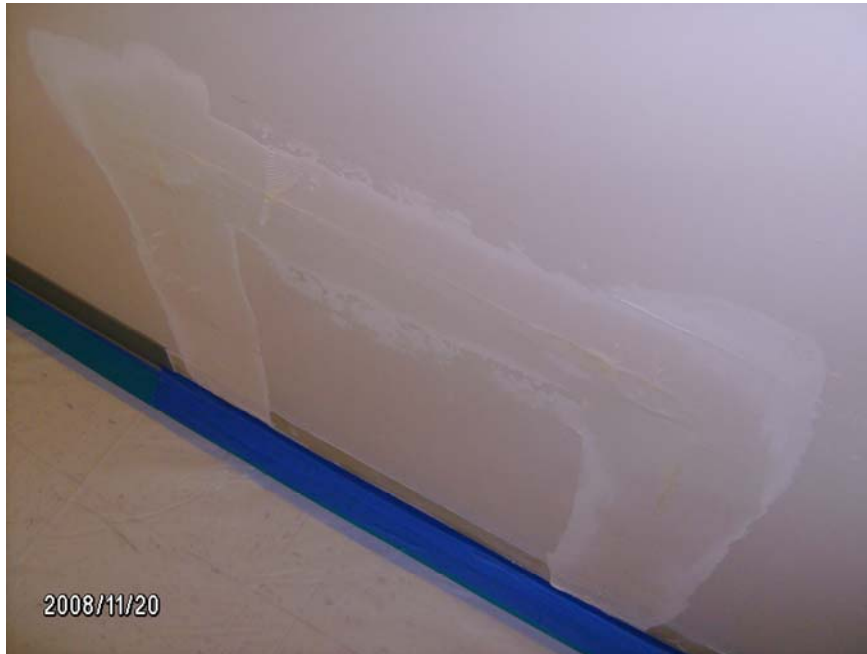
13) Image of wallboard repaired following LCD inspection within LCD-C-4 containment at time of assessment.

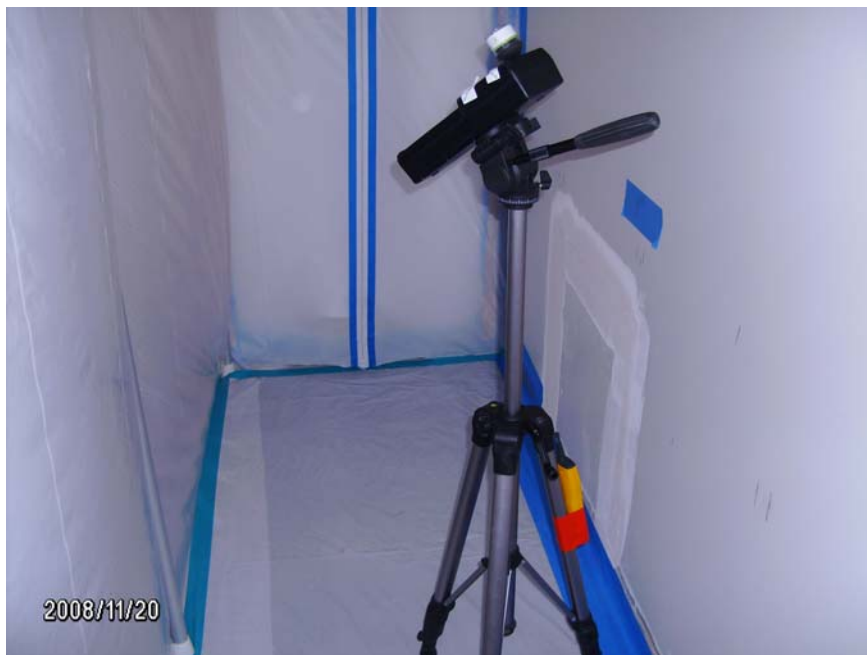
14) Image of air sampling equipment within LCD-C-7 performed at conclusion of interior clearance inspection sampling.
